25.05.2004
Teuva, Finland

CASE: SUOMEN LÄMPÖPUU OY (Finnish ThermoWood Ltd)

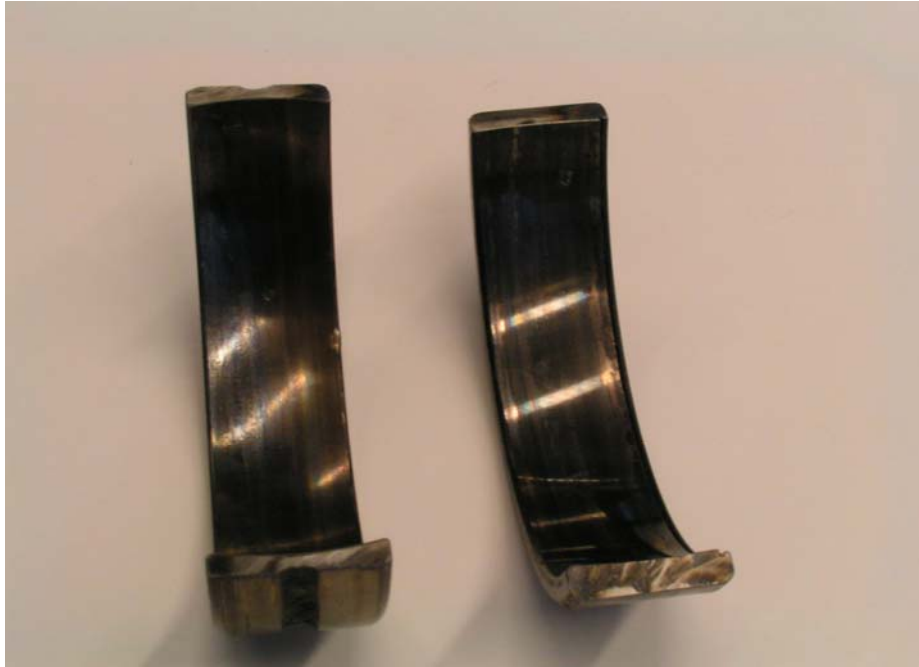
Picture No: 1. RVS-treated outer circumference of the bearing on the right. The new formed transparent, glass-like and very smooth surface structure can clearly be noticed. A normally lubricated similar kind of outer bearing circumference utilized in similar conditions and similar axle on the left. The differences of the roughness of the surface structures are visible by bare eyes even from the photographed picture.

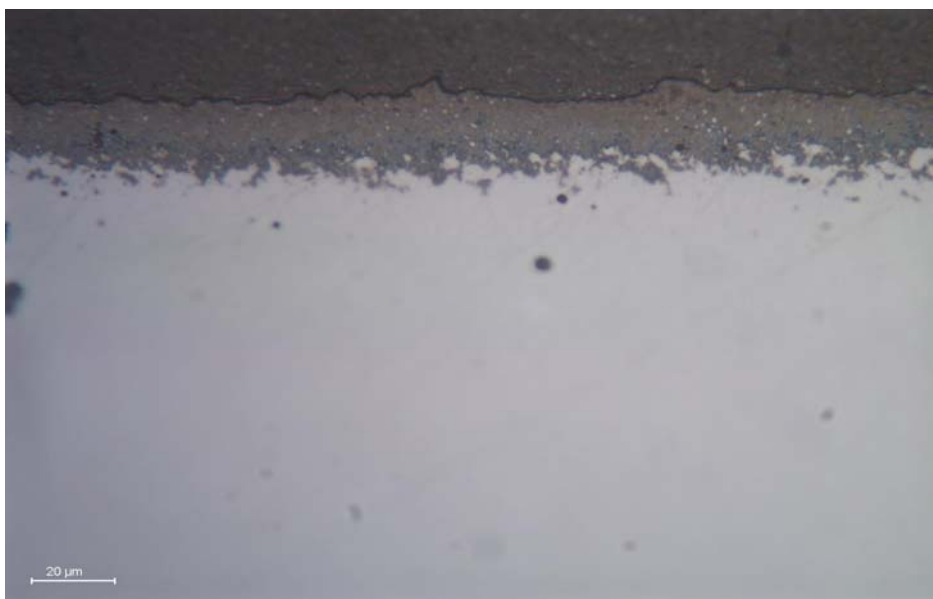
Picture No: 2. A microscopic X-ray picture of a grinded edge of the RVS-treated bearing in Picture No: 1. The darkest area is synthetic plastic into which the metal was cast before grinding the edge. The light grey area is the original metal (bearing steel). The medium grey area is the metal ceramic layer built by RVS Technology and the friction energy. The structure and thickness of the formed layer (about 15 μm) can be clearly seen. The scale down left.

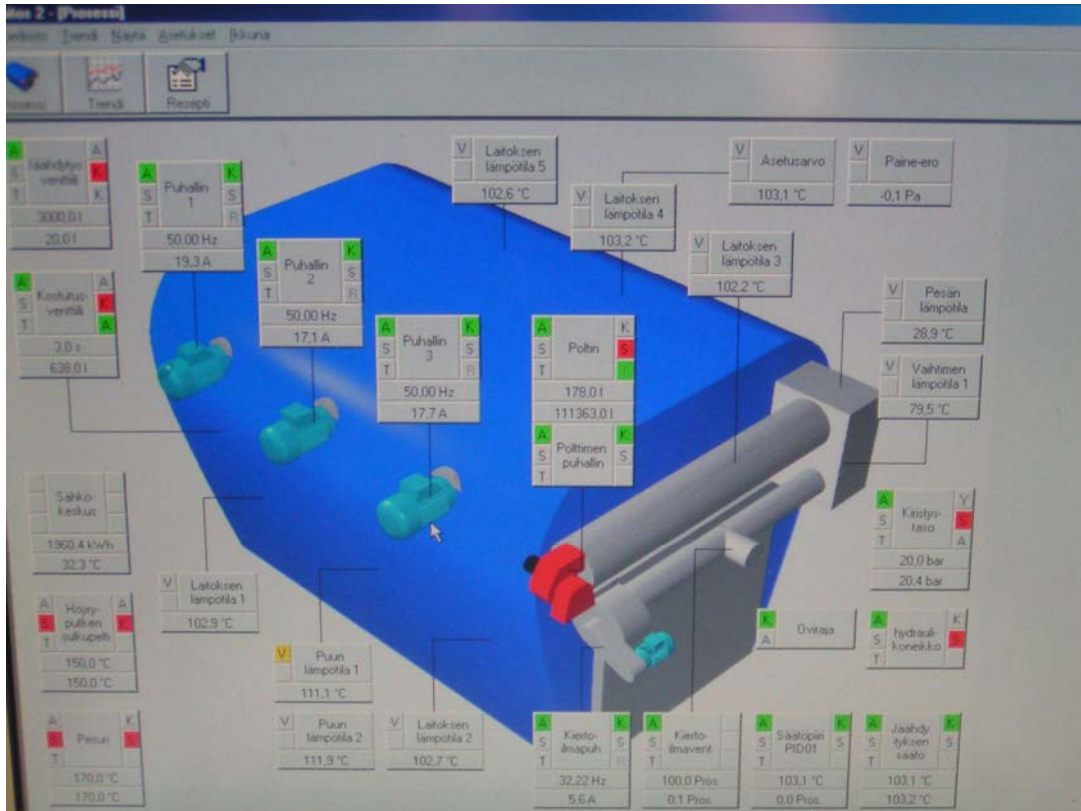
The temperatures of the wood and the current consumptions of the different fan units and other devices of the establishment (oven) are followed by the monitors of the control room (Picture No: 3.). After a few hours of operation a reduction of 5% was noticed in the current consumption of the engine driving the treated fan. This is significant as only one bearing (the one inside the oven) of the total 4 bearings of the axle/engine line of the fan was treated with RVS-grease-mixture. RVS-mixture was added few times following the normal lubrication program.

Picture No: 3. The Control Room Monitor of Suomen Lämpöpuu Oy. Wide range of information of the thermo wood treatment-process, such as operative temperatures of different devices, current consumption of fans etc. are monitored and controlled via the monitors. The middlemost fan is the one treated with RVS Technology grease. The current consumption of this particular fan dropped with 5% in few hours time from the treatment from 18,0A to 17,1A, even though only one of the total 4 bearings was treated with the RVS Technology grease.
