# **Load Test of Geared Engines of the Company SEW Eurodrive on the Premises of the Company ELEKTRO-MASCHINENBAU Bogner GmbH & Co. KG**

## **Purpose:**

The test examines the temperature and current behaviour of 4 worm-gear engines without gear oil at nominal load to determine the emergency operating features of the engines. It observes the difference between 2 engines, which have been treated with RVS Technology Gel, and 2 untreated engines.

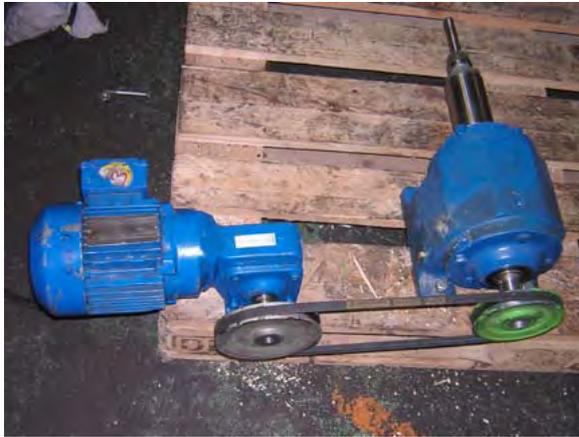
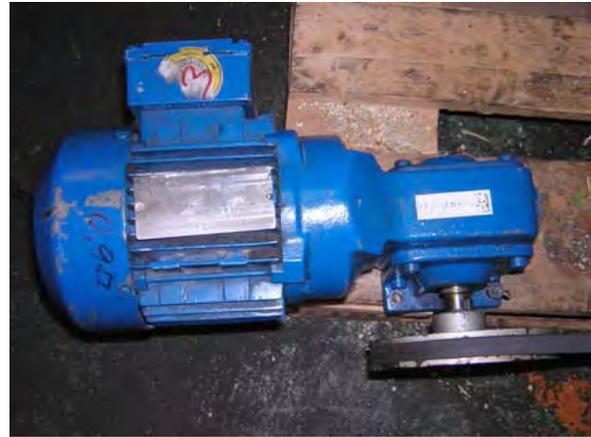
Breadboard Construction: Engine 3 with load spindle

Before the test, the engines were disassembled, the oil was removed and the engine was washed with a detergent. The engines were then successively connected at a load spindle with a ratio of  $i \sim 200$ . The temperature and current flow were recorded during the test, and it was waited until the engines were got blocked or were destroyed. Finally, the gears were dismantled and photographed.

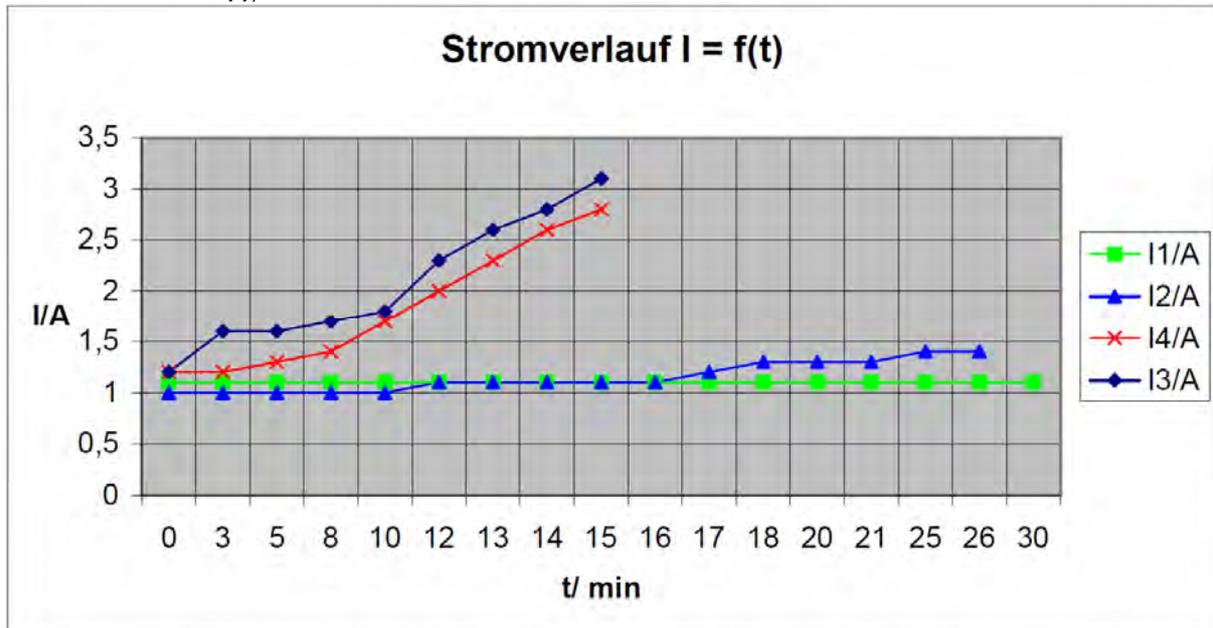
Current Flow  $I = f(t)$

I1, T1=Engine 1; I2, T2=Engine 2; I3, T3=Engine 3; I4, T4=Engine 4

- Engines 1 and 2 were treated with RVS Technology Gel
- The current was measured in each motor phase of the engines
- The temperature was measured at the front end of the gearbox housing

As you can see from the graph, the current and temperature have a steep rise in both untreated geared engines 3 and 4. After a short time, significant scuffing noise could be heard. After about 15 minutes, the two untreated engines 3 and 4 were blocked and further operation was no longer possible. The surfaces of the gears will be shown later.

A much flatter temperature increase was detected in engines 1 and 2. The currents rise only slightly.

The geared engines 1 and 2 stayed on the course significantly longer, engine 2 was blocked only after 26 minutes and engine 1 was not blocked at all. Engine 2 continued to run after a short cooling period– we assume that the bearing had jammed due high temperatures. The test with engine 1 was terminated after 30 minutes, because up to then no changes had been detected in the current.
